FIELD STUDY

AMSOIL P.i.: A Study in Performance

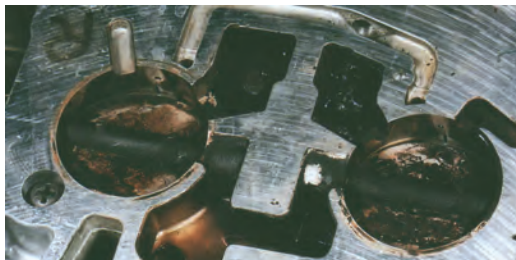
Picture J - Carburetor plates **before** P.i. treatment

Picture J shows dirty, deposit-covered carburetor plates, while **Picture K** shows the same carburetor plates cleaned with P.i.
